Focused Site Inspection Prioritization Report

Diamond International Corporation

USEPA ID No. ILD 980 683 197

August 23, 1995

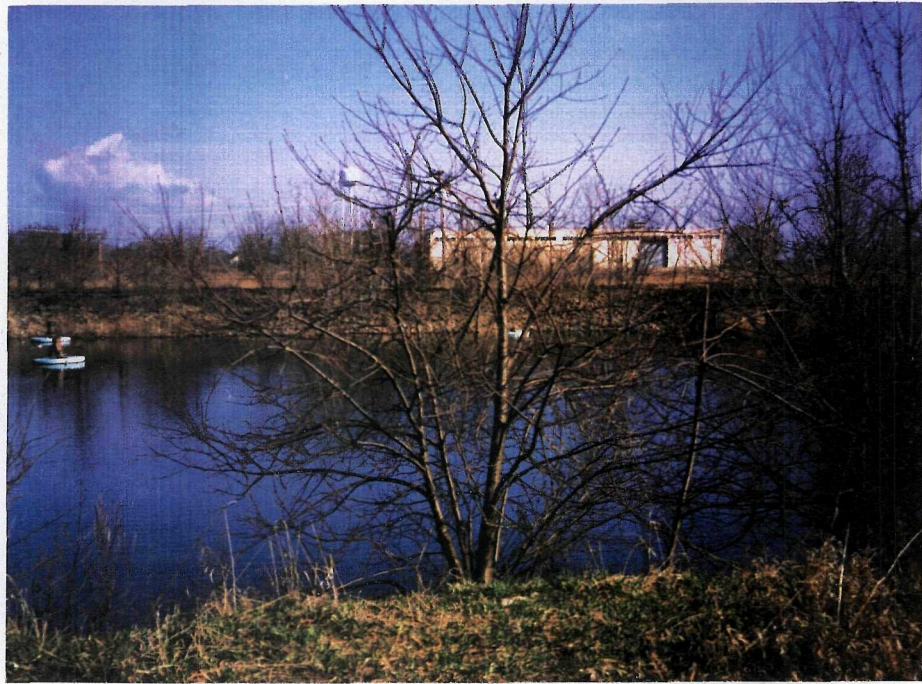
Photo Number: 1

Description: Large lagoon with aerators,
water, and rocky shore. Onsite storage
building in background.

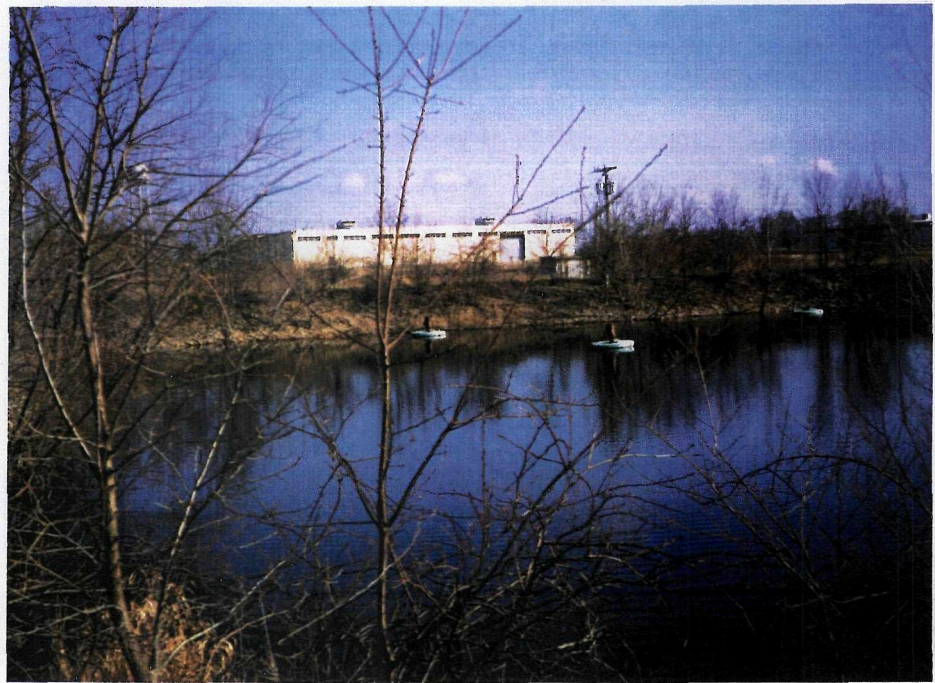
Photo Number: 2

Description: Large lagoon with aerators,
water, and rocky shore. Onsite storage
building in background.

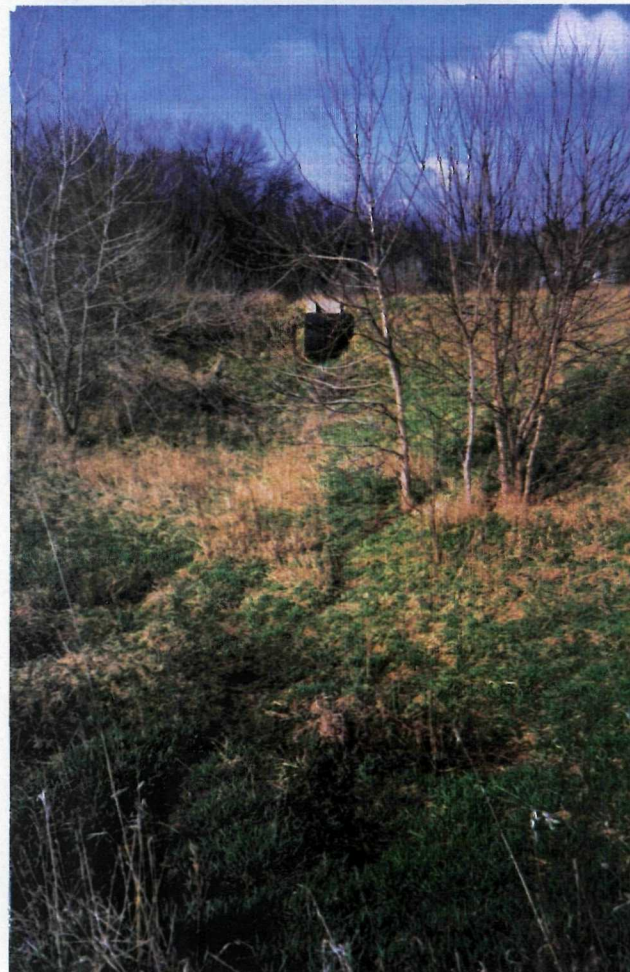
Photo Number: 4

Description: The second small lagoon (south
of the first small lagoon). No standing water.
Weir in background which leads to a sealed
underground drainage pipe.

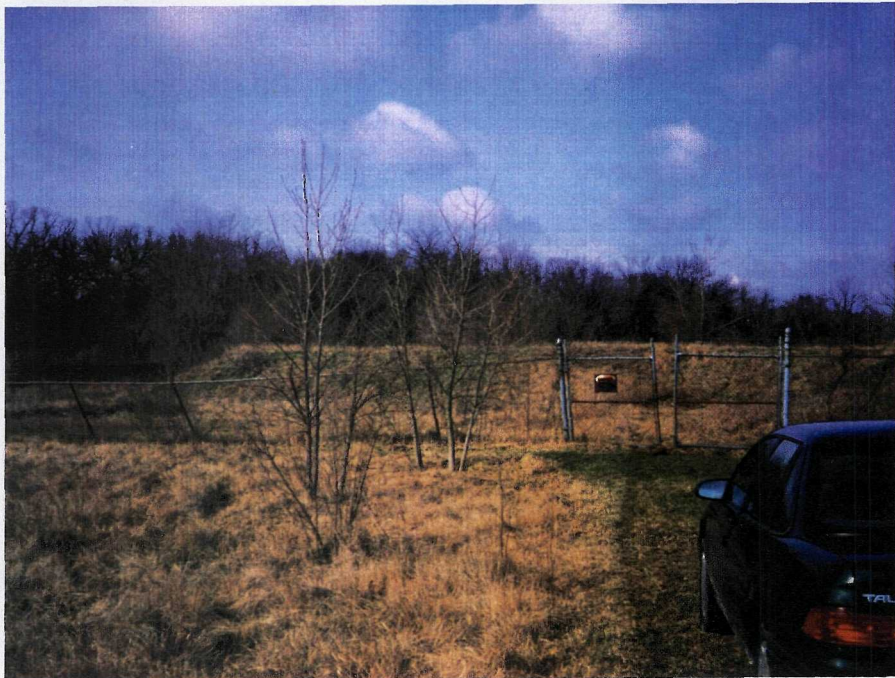
Photo Number: 5

Description: Gate and fence enclosing surface
lagoons. Note berms inside fence surrounding
each lagoon.
